Inspection Report

Property Address:
Lorraine
Glen Eden, OR

Date: 4/16/2005	Time: 12:26 PM	Report ID: Beach
Property: Lorraine Glen Eden, OR	Customer: B Lorraine	Real Estate Professional:

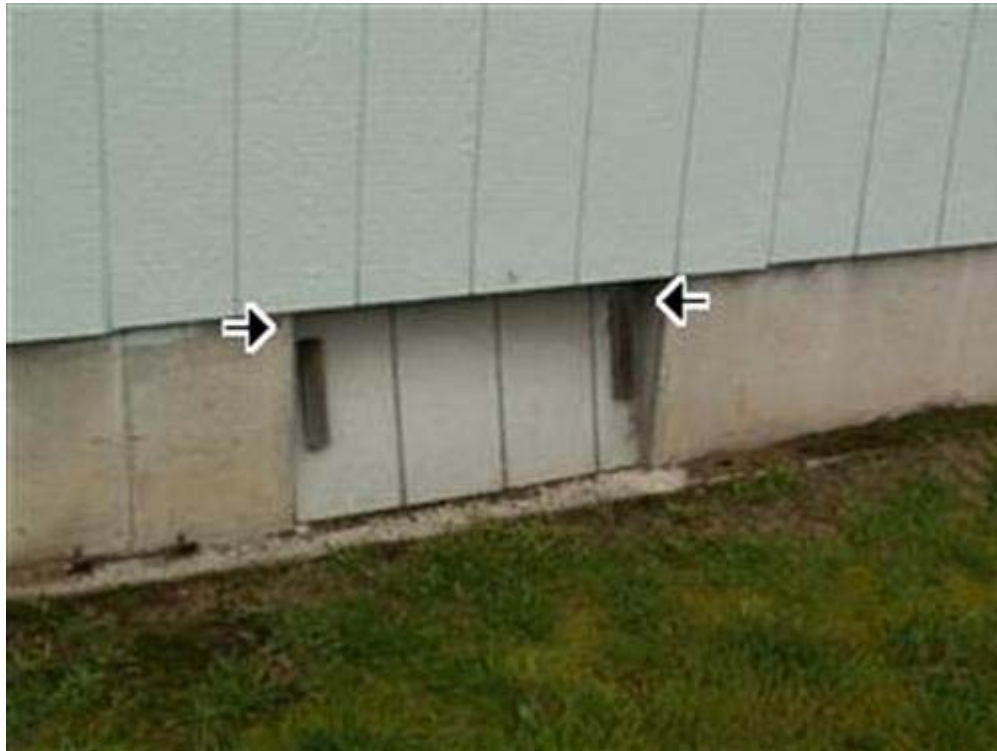
1.0 Picture 1

Hole cover to crawl space does not fit properly. Adjust and re-fit - See photo 1.0.1

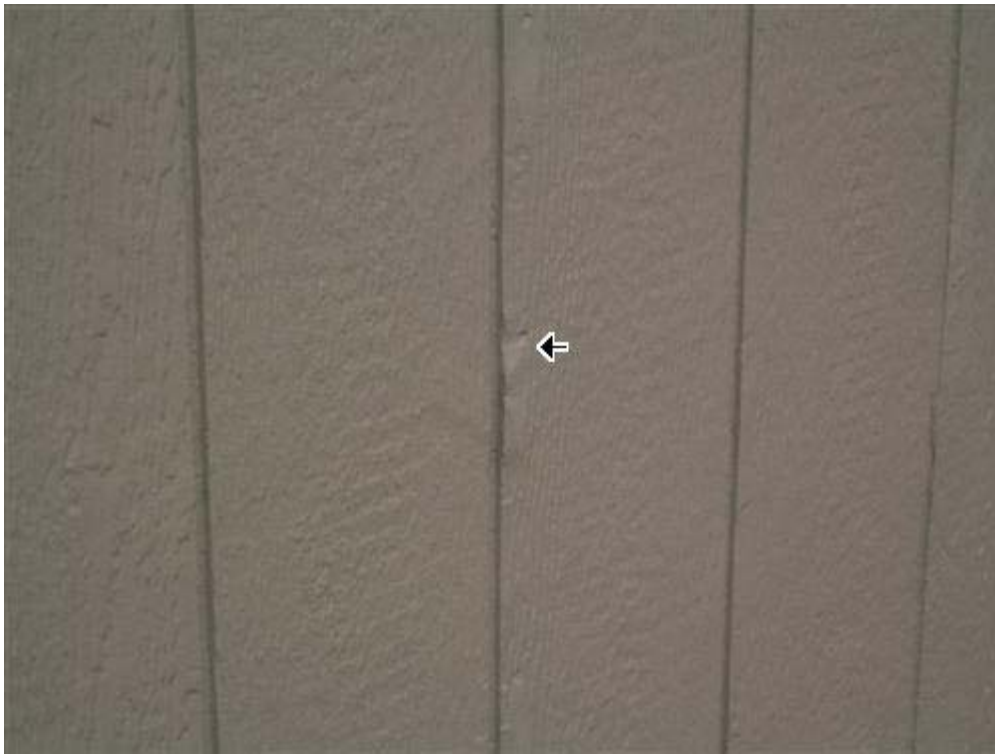
2.0 Picture 1

THE HOME SIDING IS LP. THIS PRODUCT WAS RECALLED. WE WOULD SUGGEST THAT YOU INVESTIGATE AND EVALUATE THIS SIDING. INFORMATION ABOUT THIS PRODUCT CAN BE OBTAINED BY GOING TO THE INTERNET AND TYPING "LP SIDING".

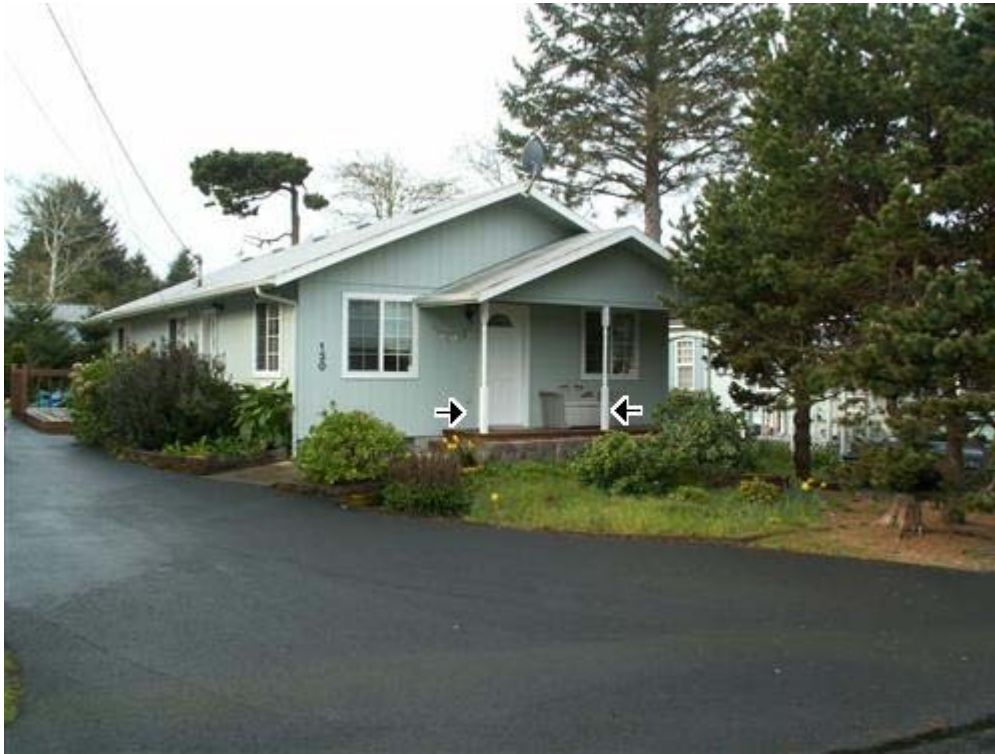
2.3 Picture 1

The front porch does not have any railing. We would suggest that railing be installed to prevent someone from falling from the porch. See photo 2.3.1

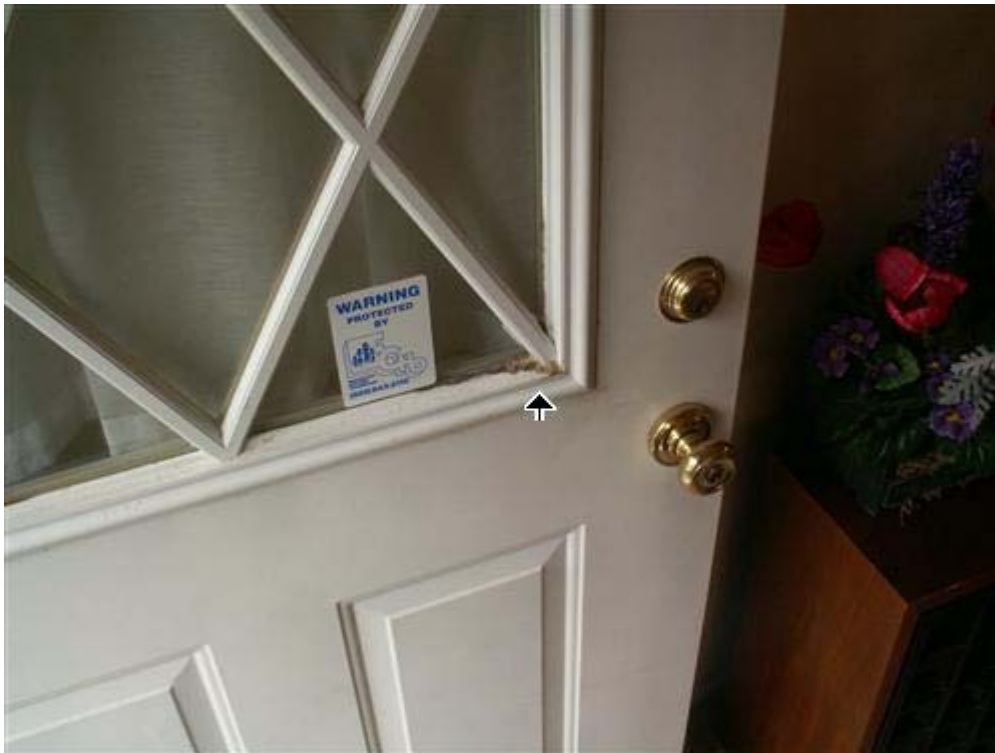
2.3 Picture 2

The back door window seal is leaking and the door has some rust in the corner. This is a maintenance item. It should be cleaned and painted to prevent rust. See photo 2.3.2

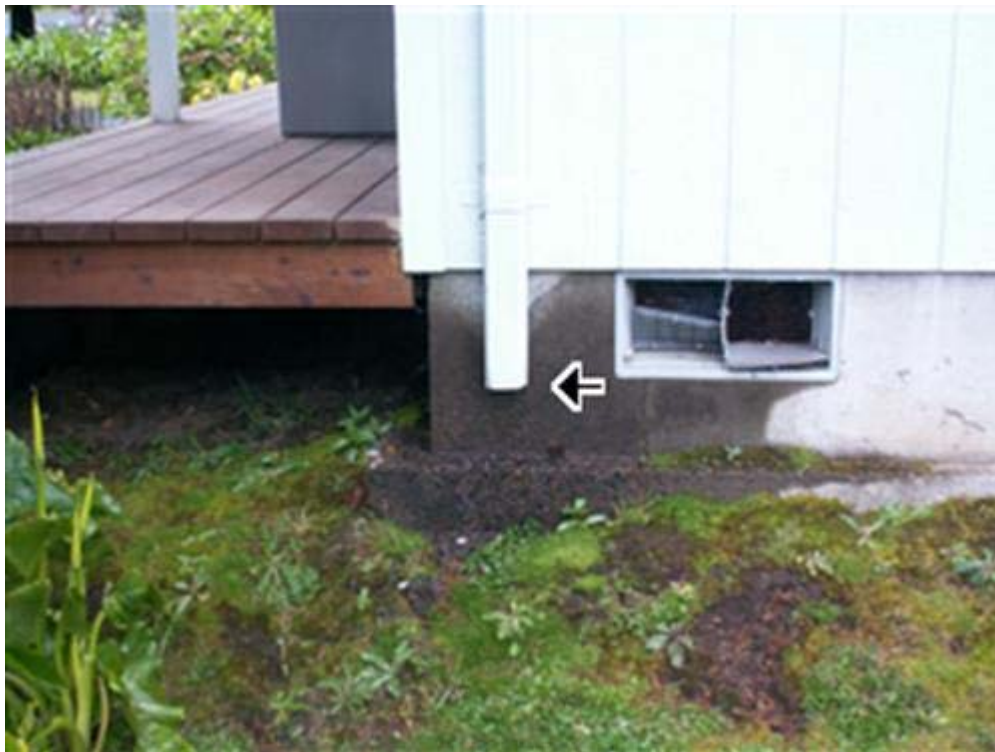
3.3 Picture 1

IN	NI	NP	RR	Inspection Items
<input checked="" type="checkbox"/>	<input type="checkbox"/>	<input type="checkbox"/>	<input type="checkbox"/>	3.0 ROOF COVERINGS ROOF COVERING: 3-TAB FIBERGLASS VIEWED ROOF COVERING FROM: WALKED ROOF Comments:
<input checked="" type="checkbox"/>	<input type="checkbox"/>	<input type="checkbox"/>	<input type="checkbox"/>	3.1 FLASHINGS Comments:
<input checked="" type="checkbox"/>	<input type="checkbox"/>	<input type="checkbox"/>	<input type="checkbox"/>	3.2 SKYLIGHTS, CHIMNEYS AND ROOF PENETRATIONS SKY LIGHT (S): NONE CHIMNEY (exterior): N/A Comments:
<input checked="" type="checkbox"/>	<input type="checkbox"/>	<input type="checkbox"/>	<input checked="" type="checkbox"/>	3.3 ROOFING DRAINAGE SYSTEMS Comments: Downspout needs extension and a buried drain line to carry water away from home at right side (facing front).

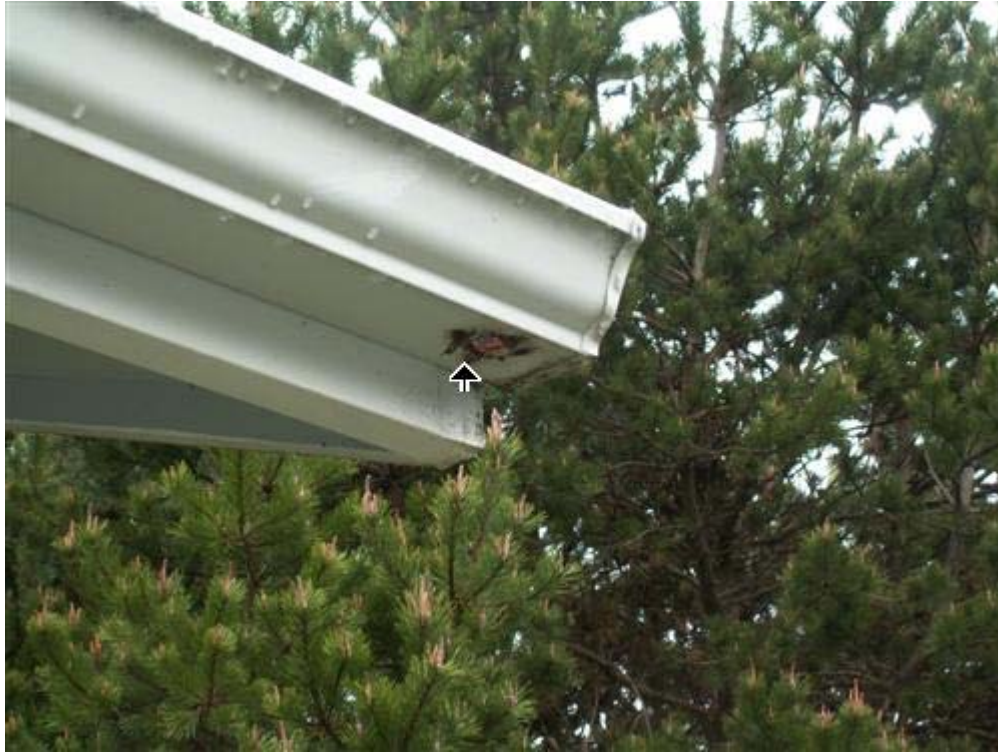
3.3 Picture 2

The front gutters do not have down spouts. have a contractor evaluate and make the necessary repairs. See photo 3.3.2

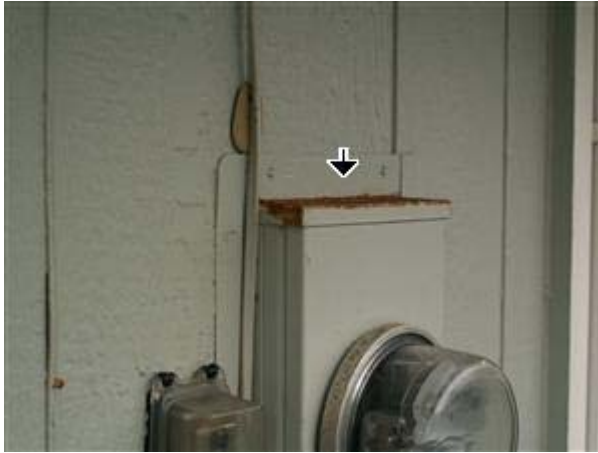
5.1 Picture 1

5.1 SERVICE AND GROUNDING EQUIPMENT, MAIN OVERCURRENT DEVICE, MAIN AND DISTRIBUTION PANELS
PANEL CAPACITY: 200 AMP
PANEL TYPE: CIRCUIT BREAKERS
ELEC. PANEL MANUFACTURER: MURRAY
Comments:
 The meter box is rusting on the top. Rusting will, in time, require replacement. Have a contractor make the needed repairs to prevent rusting.

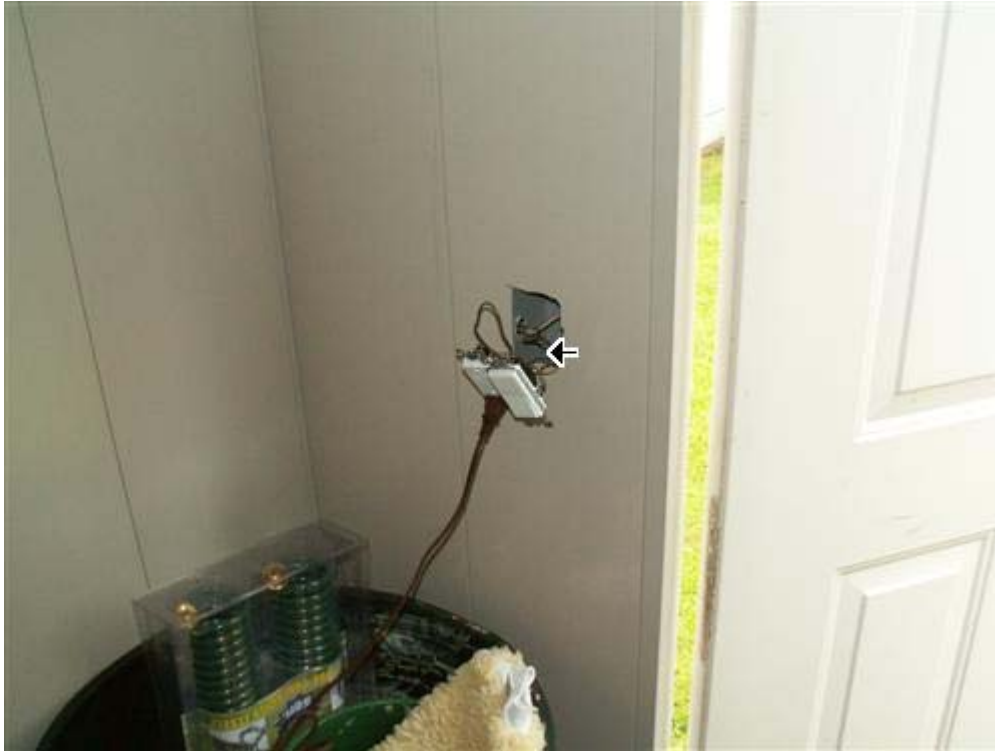
5.3 Picture 1

5.3 CONNECTED DEVICES AND FIXTURES (Observed from a representative number operation of ceiling fans, lighting fixtures, switches and receptacles located inside the house, garage, and on the dwelling's exterior walls)
Comments:
 A switch and receptacle is hanging loose in the shed. Have an electrician make the necessary repairs. See photo 5.3.1

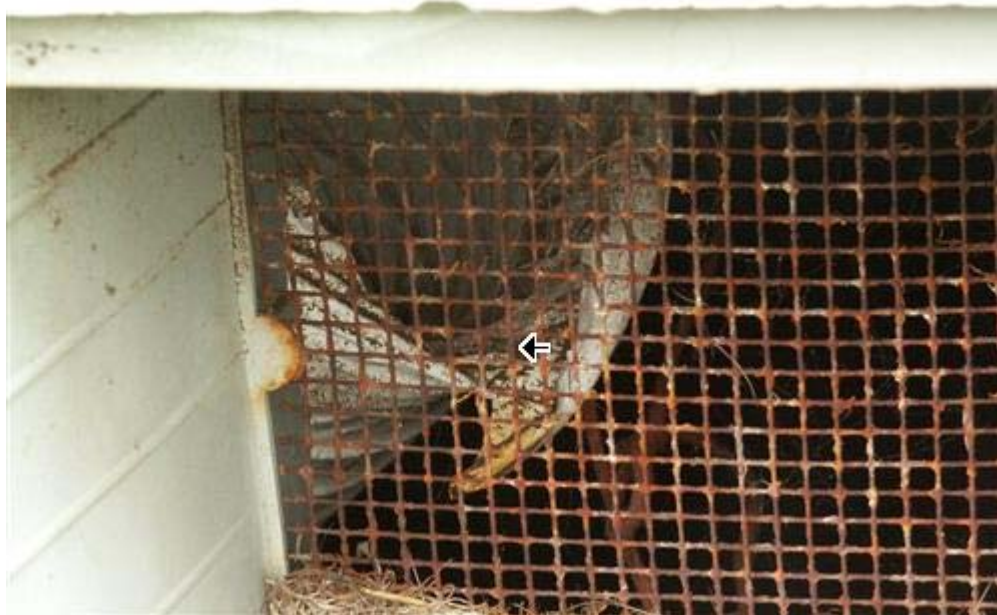
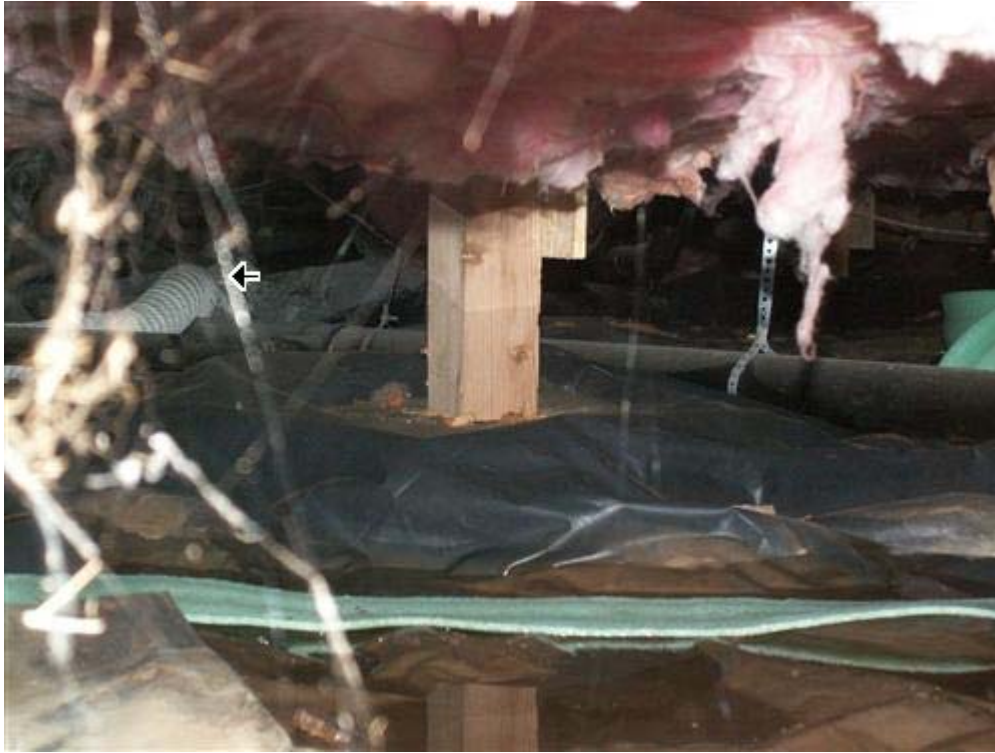
8.2 Picture 1

Vent pipe from dryer is not connected - REPAIR OR REPLACE. Lint and moist air are entering the crawl space and can cause moisture damage.

<input checked="" type="checkbox"/>	<input type="checkbox"/>	<input type="checkbox"/>	<input checked="" type="checkbox"/>	8.2 VENTING SYSTEMS (Kitchens, baths and laundry) EXHAUST FAN TYPES: NONE DRYER POWER SOURCE: 220 ELECTRIC DRYER VENT: FLEXIBLE VINYL Comments: Vent pipe from dryer is not connected - REPAIR OR REPLACE. Lint and moist air are entering the crawl space and can cause moisture damage.
-------------------------------------	--------------------------	--------------------------	-------------------------------------	--------------------------------------------------------------------------------------------------------------------------------------------------------------------------------------------------------------------------------------------------------------------------------------------------------------------------------------
